MIDDLE CALAPOOIA RIVER ASSESSMENT AND PROJECT IMPLEMENTATION PLAN

April 30, 2008

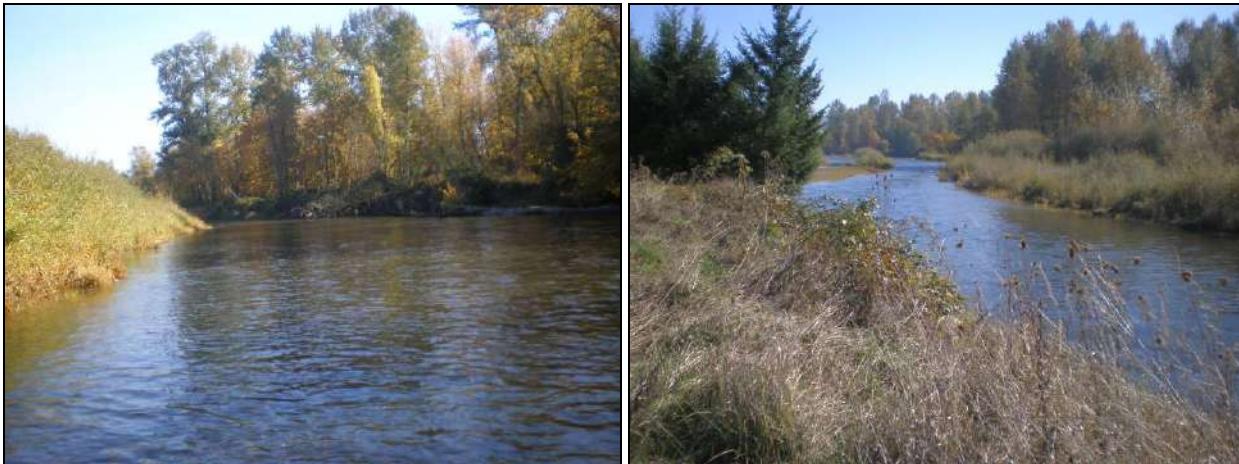
Figure 3-1. Examples of riparian conditions in the Middle Reach of the Calapooia River. Multiple age classes of willows populate depositional features, while mature floodplain forests characterize older floodplains (left). Varied riparian conditions exemplify much of the Middle Reach (right).

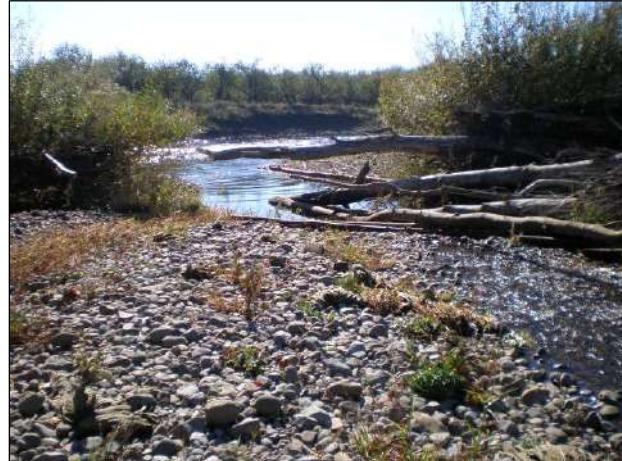
Figure 3-2. An example of a backwater habitat that provides juvenile rearing habitat connected to the river.

Rearing: Juveniles rear in the upper river and smaller tributaries for as long as 4 years in fresh water; prefer pools with cover, large wood (Figure 3-2), and cool water temperatures (less than 64 °F), and high dissolved oxygen levels.

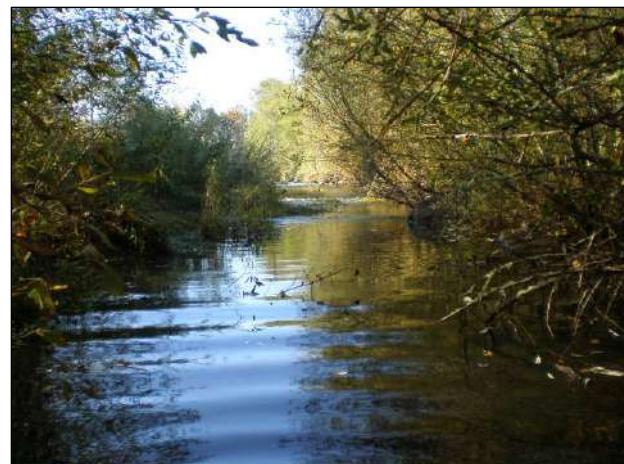
Figure 3-3. An example of a floodplain channel that is inundated over a range of mainstem stages. These habitats provide off-channel habitat for fish and amphibians.

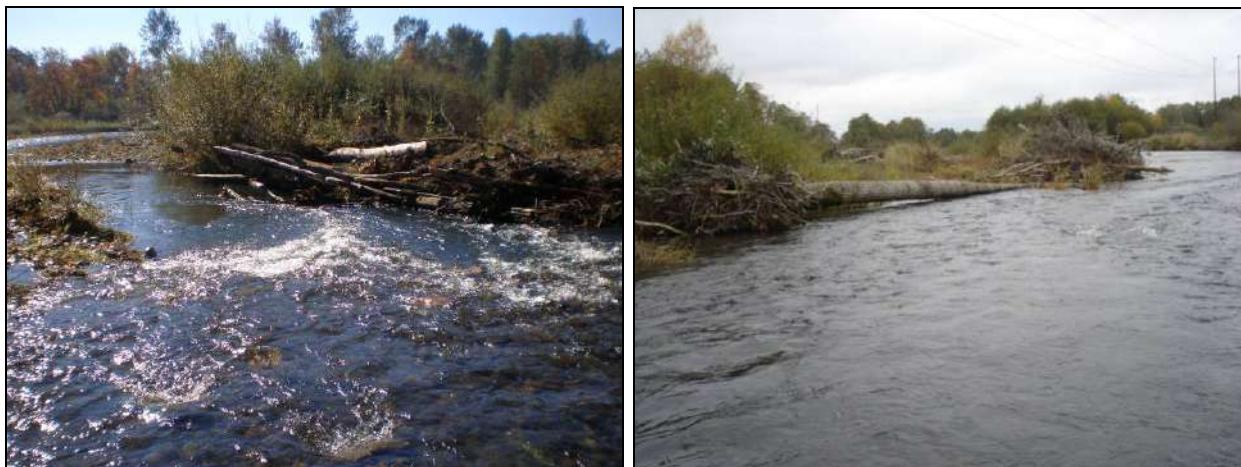
Figure 3-4. Large wood provides overhead cover for fish habitat and also influences channel morphology. Large wood is a vital component for maintaining fish habitat in the Calapooia River.

Large wood historically played an important role in creating habitat diversity (Figure 3-4). However, log drives, riparian logging, and removal of large wood from the river and tributaries have reduced the prevalence of habitat-forming trees in the Middle Calapooia River. Similar to other areas in the Willamette Valley, logs on the floodplain are cut either for firewood or to reduce the chance of logs damaging property or infrastructure during floods (Figure 3-5). Large wood is important for fish in streams and rivers because it creates pools, hiding areas, bars of gravel that are sorted by size, and is a substrate for aquatic insects.

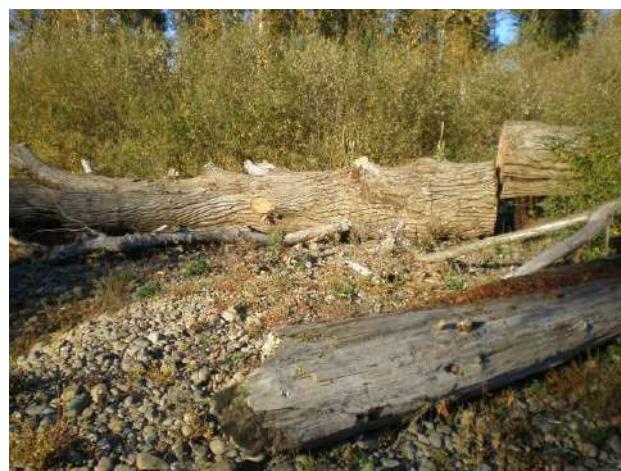
Figure 3-5. An example of a large log on the Calapooia River floodplain upstream from Brownsville that was recently cut. The log will no longer function as a habitat forming element.

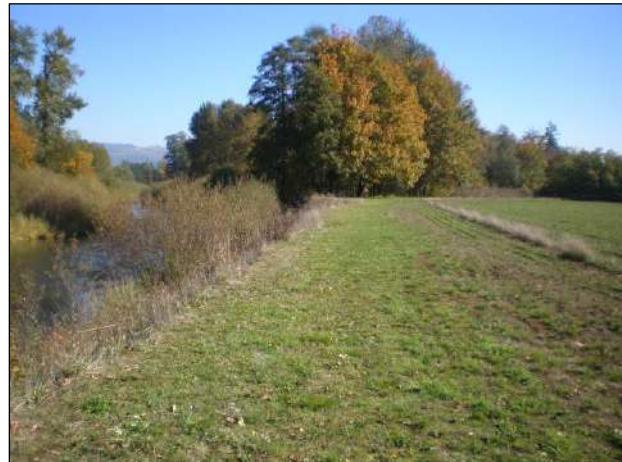
Figure 3-6. A grass seed field paralleling the Calapooia River. The site is characterized by a minimal riparian buffer separating the river from agricultural production.

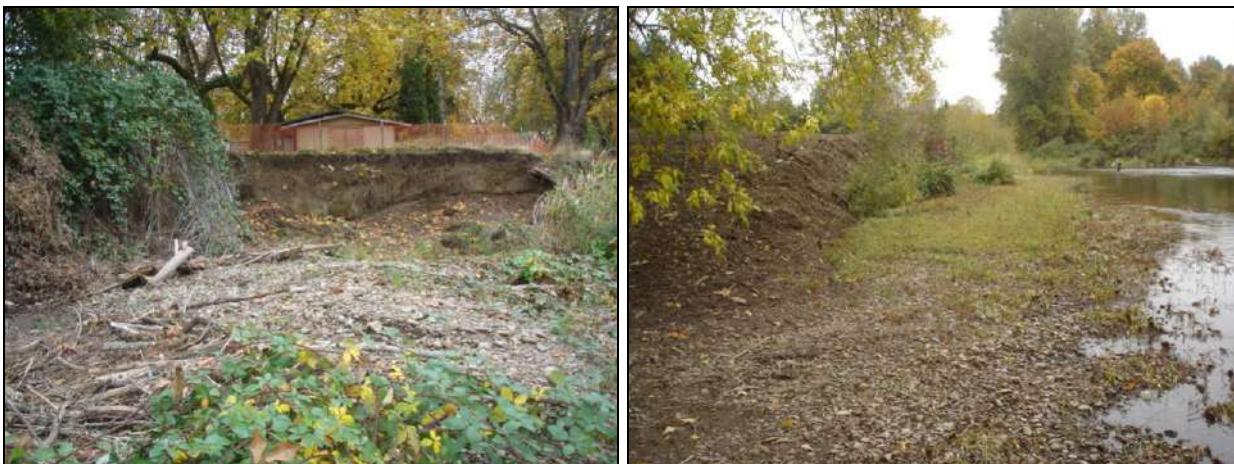
Figure 3-7. Working with landowners to address accelerated bank erosion (left) and providing alternatives to dumping fill along the channel (right), are two educational efforts that can be pursued to reduce sediment loading to the Calapooia River as well as slow property loss.

Where rivers have been treated in such a way, conflicts among landowners and declines in fish habitat invariably occur (Figure 3-7). In addition, stopping the meandering on one segment of river usually causes an upstream or downstream increase in meandering and erosion, often creating problems for neighboring landowners. By decreasing the meandering of a river, water velocity increases, the river bottom downcuts, gravel bars become coarser, and zones of still water decrease; all of which are detrimental to fish. Treating a bank to control meandering can not be justified on the grounds of decreasing overall river sediment loads, since the amount of bank material is so small compared to the river's overall sediment load.

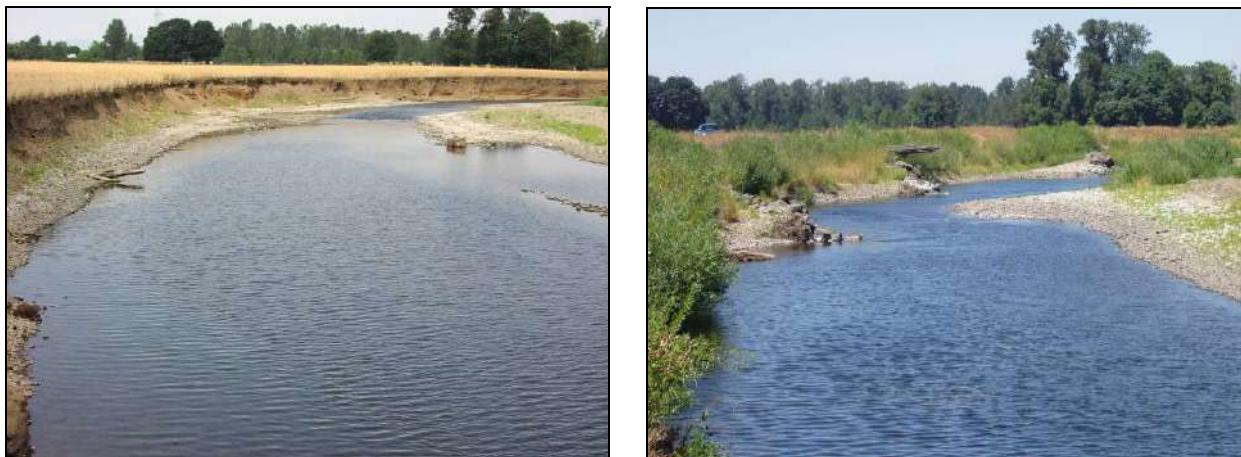
Figure 4-1. Examples of eroding bank (left) at the Carbajal site pre-project and more recent (right) photo showing effects of bank stabilization using rock barbs and revegetation.

Bank stabilization projects, using rock barbs, are located at three sites. These projects consist of variations using rock barbs, bank re-shaping, vegetation, and/or large wood. For the most part, the barb projects have stabilized bank erosion as illustrated by the Carbajal site (station 104+00 to 111+00) in Figure 4-1. The landowner was losing over 10 ft of streambank every year with some localized erosion exceeding 25 ft per year due to lateral erosion prior to the project. Now, the bank has been stabilized and a riparian corridor has been established that consists of willows on the bank and trees and shrubs on the floodplain. At the Oakley site just upstream (station 68+00), the bank stabilization project was not revegetated as well and is showing signs of additional bank erosion.

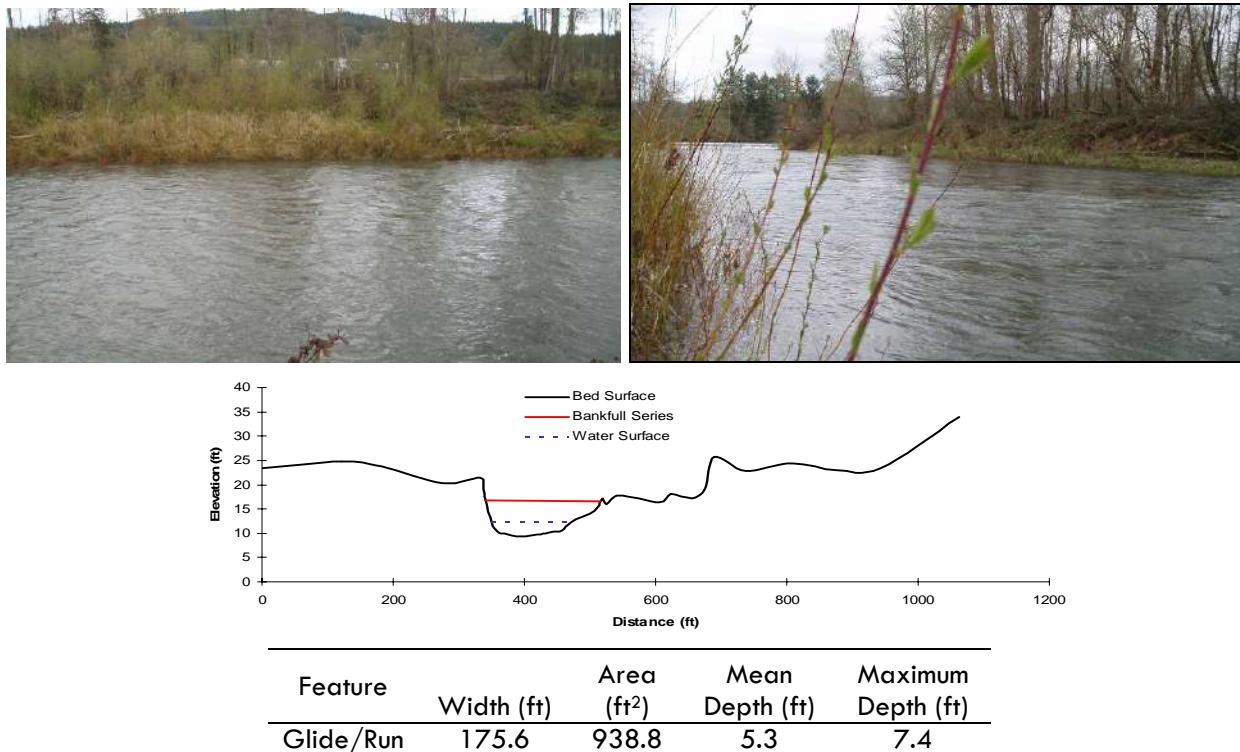
Figure 4-2. The cross-section at Sta. 6+00. The upper left photo shows the right floodplain noted by the flat section in the right portion of the cross-section diagram. The upper right photo is a view up river towards the left bank.

Figure 4-2 depicts the cross-section at Sta. 6+00. The photos capture the features surveyed in the cross-section. For example, the flat inset floodplain in the right portion of the channel cross-section immediately above the estimated bankfull elevation, is the willow surface in the upper left photograph. The low terrace shown forming the left bank in the cross-section figure is captured in the upper right photograph.

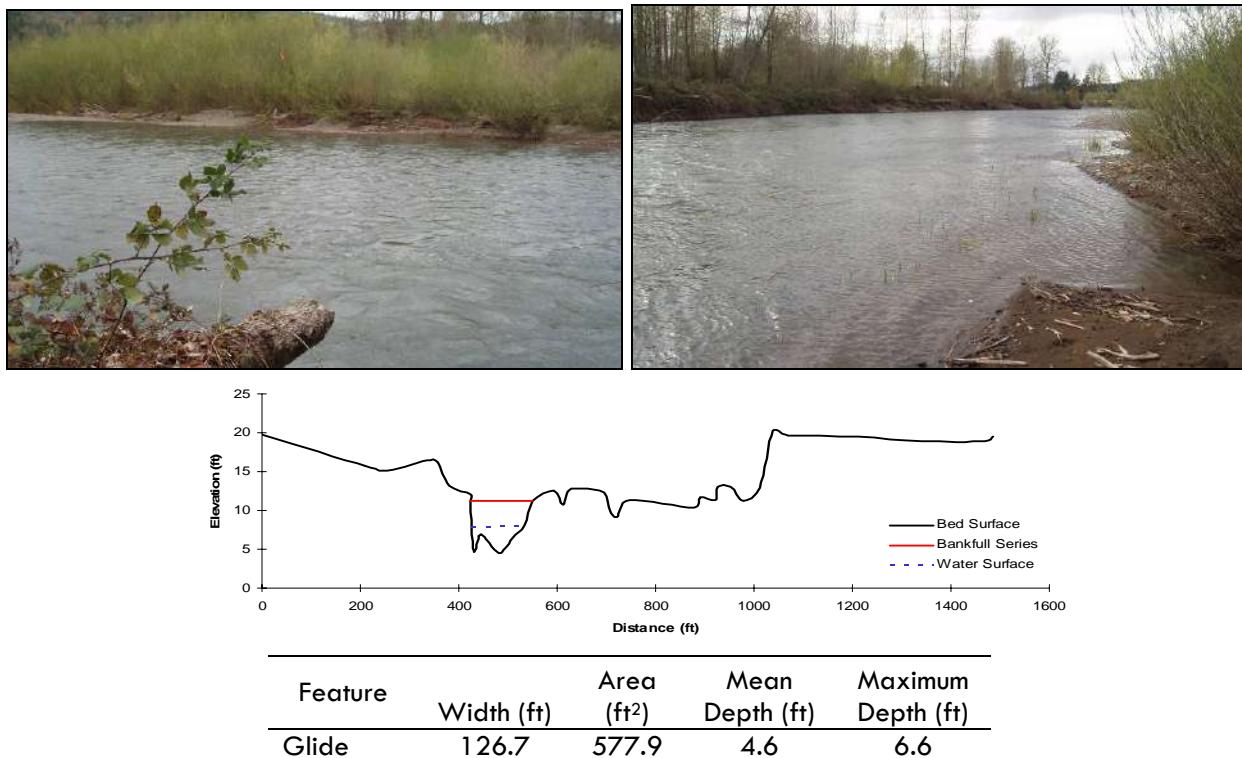
Figure 4-3. The cross-section at Sta. 29+00 in the Rosgen C4 stream type portion of Reach 1. The upper left photo shows the right floodplain noted by the flat in the right portion of the cross-section diagram. The upper right photo is a view down river towards the left bank. The beltwidth is almost twice as wide at Sta. 29+00 compared to Sta. 6+00, a Rosgen B4c stream type.

diverse floodplain morphologies are typically associated with a broadening of the channel beltwidth. The undulations of the floodplain shown in Figure 4-3 show the multiple sidechannels and swales that are located on the floodplain north of the baseflow channel. Focusing restoration efforts on these areas of the stream corridor is suggested for enhancing juvenile fish rearing habitat and refugia.

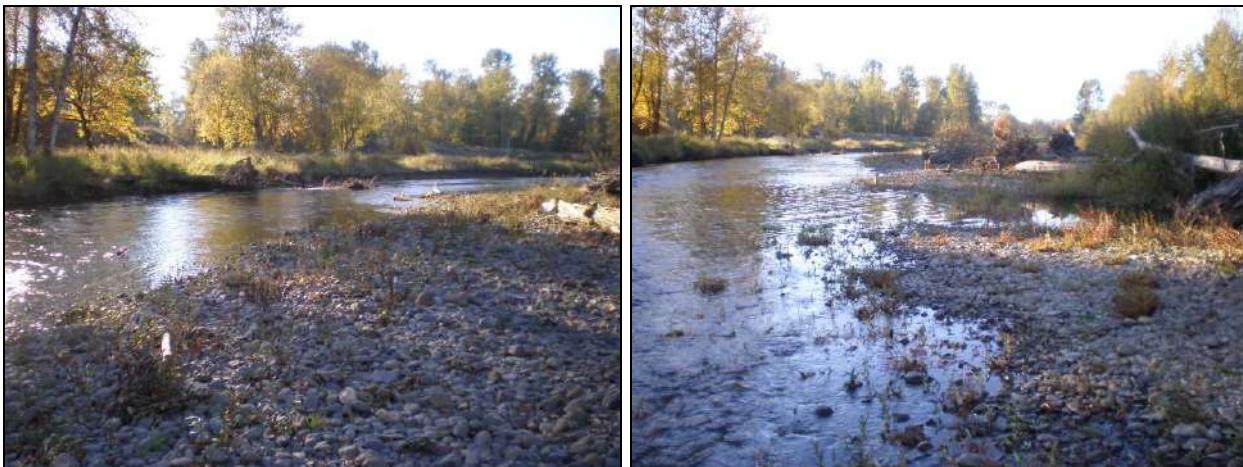
Figure 4-4. Typical vegetation conditions on the southern floodplain (left) and a point bar with backwater habitat (right).

The floodplain morphology in the reach is influenced by the valley bottom width and river processes. At the beginning of the reach in the C stream type section, the valley bottom width permits narrow floodplain development. The riparian community is dominated by a cottonwood overstory and willow shrub layer. Several large point bars between the start of Reach 3 and the Brownsville Bridge suggest a mobile streambed and localized sediment storage. A dispersed riparian canopy is located on the southern floodplain. Vegetation patterns reflect the agricultural practices that predominate on the south side of the Calapooia River upstream of the Brownsville Bridge. Figure 4-4 includes some typical photographs of the upstream half of Reach 2.

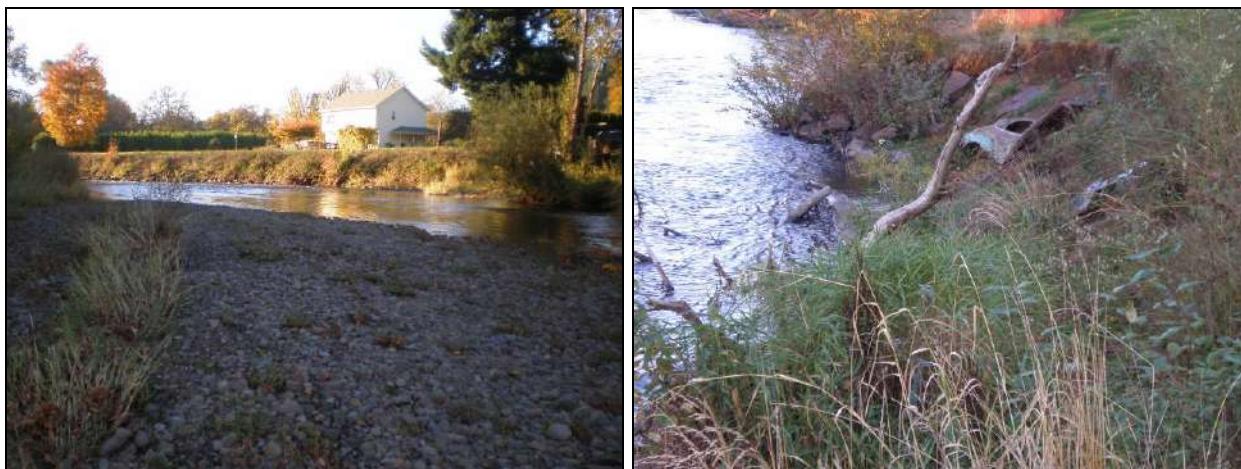
Figure 4-5. Bank stabilization sites in Reach 2 include the house protection at Sta. 160+00 (left) and at Pioneer Park.

Two riprap sites were identified upstream of Brownsville Bridge. The upstream site protects a residence built adjacent to the river. The downstream site appears to be at a former river crossing location. The treated area is localized. Downstream of the Brownsville Bridge, the left bank is stabilized for approximately 2,000 ft. This project was likely implemented in the early 1960s when an extensive bank stabilization effort was undertaken. A concrete slab immediately downstream from the bridge may be an old crossing or the remnant of some other infrastructure. Figure 4-5 illustrates bank stabilization treatments in Reach 2.

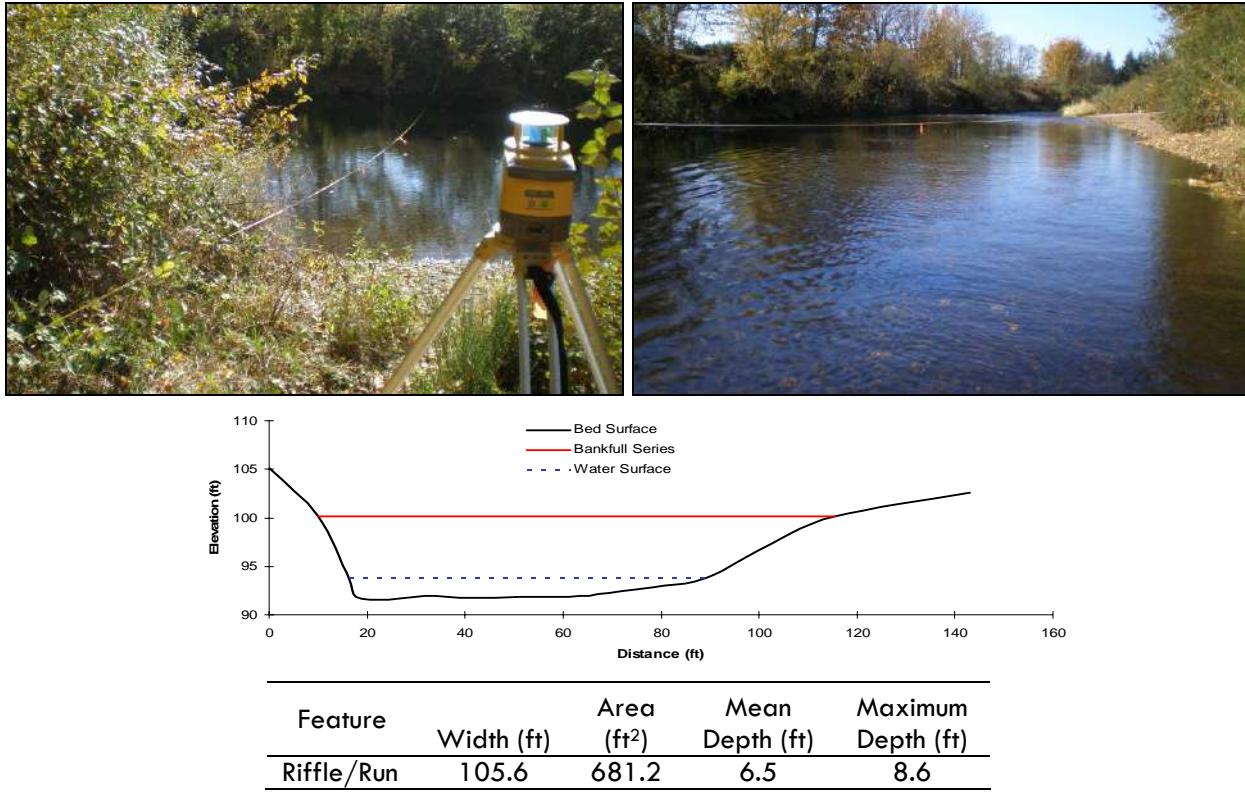
Figure 4-6. The cross-section at Sta. 188+50. The upper left photo shows the view across the river from the right bank. The upper right photo captures the river corridor downstream from XS-2.

A hydraulic channel cross-section was established in Reach 2 adjacent to Pioneer Park downstream from Brownsville Bridge. A channel survey was completed on October 25, 2007. The survey included a cross-section, channel profile, discharge measurement, and pebble count in the C stream type portion of Reach 2. Summary information from the survey is included in Figure 4-6. The photos capture typical river corridor conditions in the vicinity of Pioneer Park. The left bank is stabilized with riprap. The right bank is a point bar with medium density riparian vegetation at the topographic break. The right floodplain has been kept in a moderately natural state with a riparian canopy and grass floodplain surface. The shrub layer that would be expected in a more natural setting was removed in the past to create the park conditions. The cross-section also exhibits the sloped point bar and flat channel bottom that predominates through the park section of the Calapooia River.

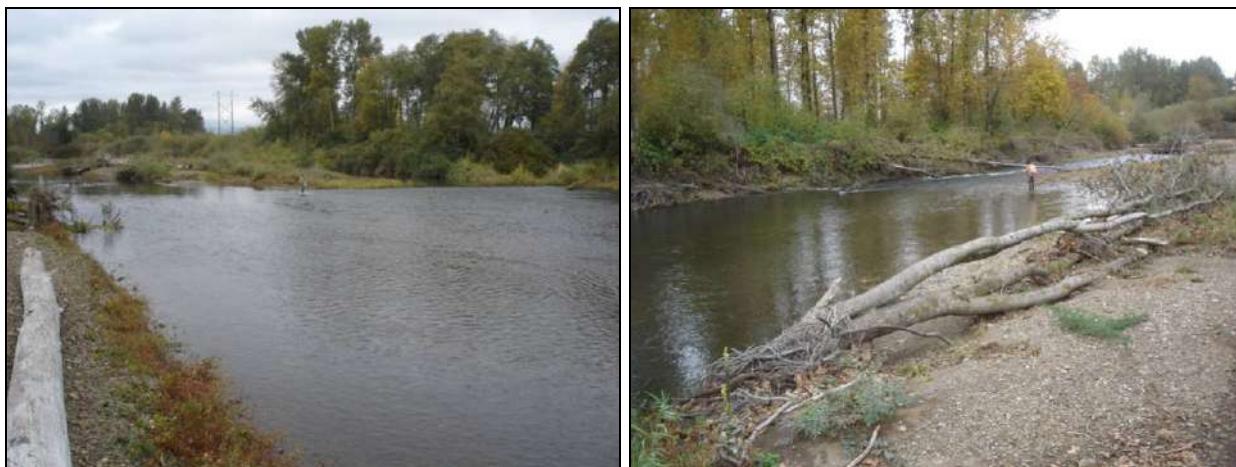
Figure 4-7. Backwater channels and large wood in Reach 3 provide a range of habitats that benefit juvenile and adult fish in the Calapooia River.

Floodplain expanses in Reach 3 provide a range of habitats beneficial for both fish and wildlife. Backwater habitats, groundwater-fed percolation channels, and floodplain ponds are inundated year round but may only be connected with the mainstem Calapooia River during elevated flows (Figure 4-7). Hyporheic (shallow subsurface flow) or groundwater upwelling in these floodplain features provide cool water refugia for fish during warmer summer months. Shallow channel margins also create cover for juvenile fish. Habitats containing large wood provide complex microhabitats for juvenile fish as well.

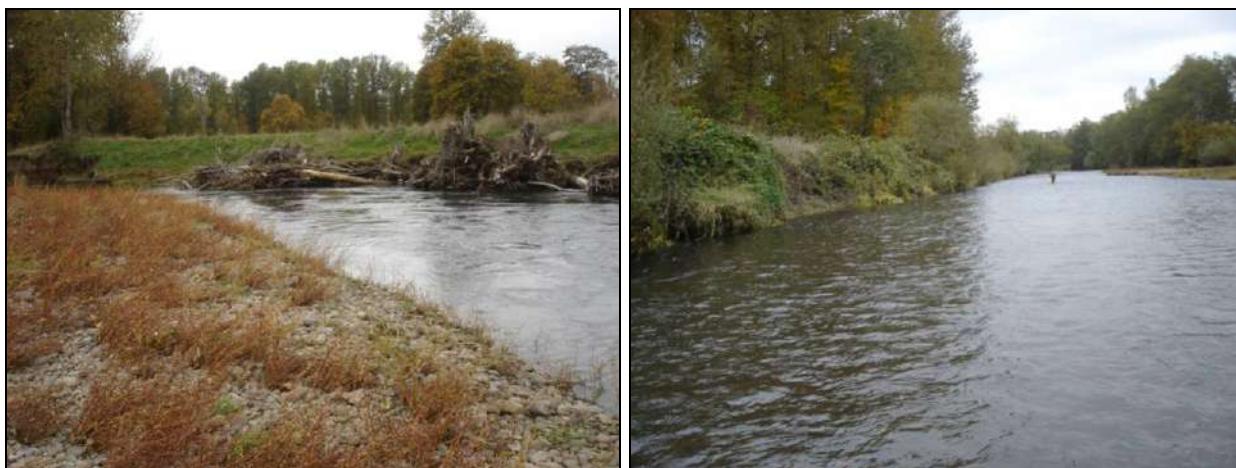
Figure 4-8. Examples of bank stabilization in Reach 3 include the Ross site (left) and an older riprap project spanning 2,000 ft from Sta. 242+00 to 262+00 (right).

Five riprap sites and a rock spur were located in the reach. Riprap sites were generally extensive and protect adjacent agricultural land. The riprap was likely installed during the 1962 effort and is largely grown over with shrubs, blackberry, and overstory deciduous trees. The Ross bank stabilization site included bank re-grading, four engineered log jams, and riparian plantings. The downstream riprap sites stabilize streambanks adjacent to agricultural fields. Figure 4-8 depicts bank stabilization projects in Reach 3.

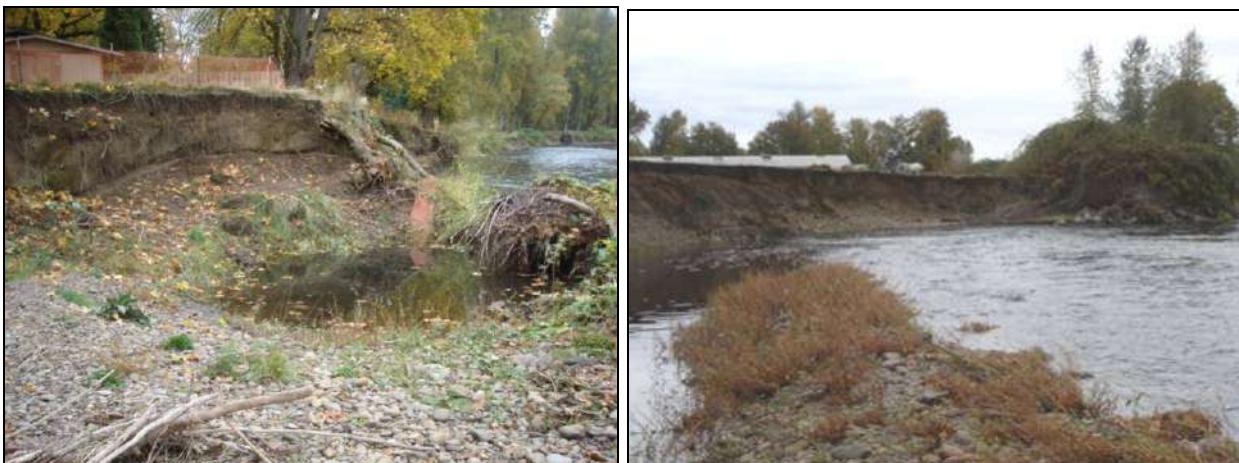
Figure 4-9. The bank erosion site downstream from Pioneer Park that continues onto the Gerber and Smith properties (left), and the vertical streambank on the Nealon property (right). The blackberry covered structure in the middle of the right photograph is a rock spur or levee.

The extensive riprap bank stabilization in Reach 3 limits lateral channel migration and related streambank erosion. However, there are four primary bank erosion areas in the reach. The first site, located downstream from Pioneer Park is experiencing accelerated bank retreat caused by eddying. The bank failure is threatening one of the park buildings and continues to erode the adjacent neighbor's property (Figure 4-10). The river is also eroding the floodplain downstream from the Ross project. The streambank has experienced accelerated erosion since 2005 (Inter-fluve 2007). This trend is expected to continue as the river migrates down-valley over time. The Nealon property located in the next meander downstream from the Ross property is also experiencing accelerated streambank failure. The vertical bank has a poor riparian condition and no toe protection capable of withstanding flood hydraulics (see Figure 4-9). The final primary bank erosion site is located on an outside meander downstream from an extensive riprap bank. Located from Sta. 262+00 to 268+00, the Calapooia River is eroding a forested floodplain. Bank erosion will recruit mature trees to the river. Other sediment sources in the reach are relatively isolated and smaller scale. Table 4-19 includes sediment source metrics in Reach 3.

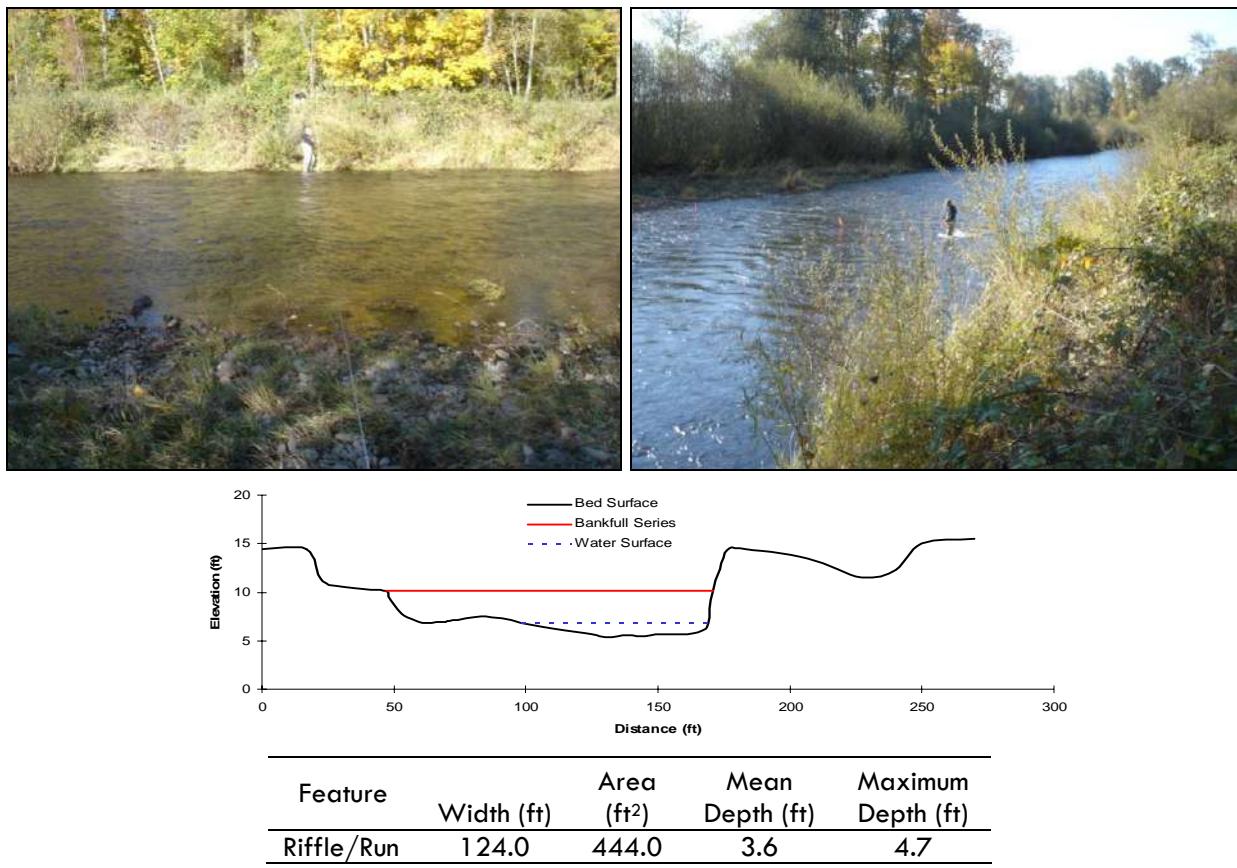
Figure 4-10. The cross-section at Sta. 254+00. The upper left photo shows a view across the river from the left bank. The right photo captures the river corridor through the cross-section location.

A hydraulic channel cross-section was established in Reach 3 downstream from the Ross Property at the waste water discharge diffuser. A channel survey was completed on October 25, 2007. The survey included a cross-section, channel profile, discharge measurement, and pebble count. Summary information from the survey is included in Figure 4-10. The photos capture typical river corridor conditions in the vicinity of Pioneer Park. The left bank is stabilized with riprap. The right bank is point bar with moderately dense riparian vegetation at the topographic break. The right floodplain has been kept in a moderately natural state with a riparian canopy and grass floodplain surface. The shrub layer that would be expected in a more natural setting is mowed to maintain the park conditions. The cross-section also exhibits the moderately sloped point bar and flat channel bottom that predominates through the park section of the Calapooia River.

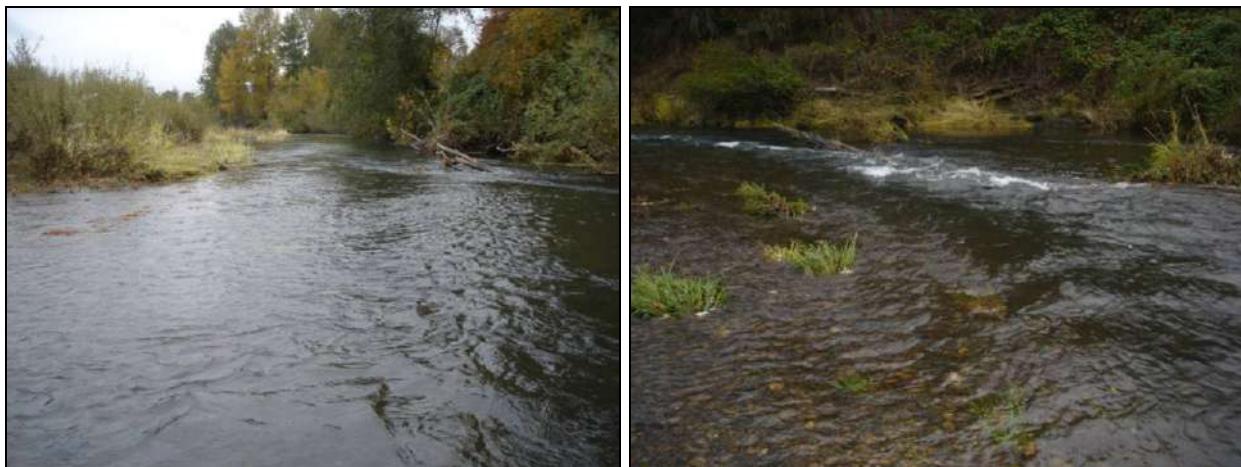
Figure 4-11. Example habitats in Reach 4 include glide-riffle transitions (left) and runs influenced by large wood (right).

The extensive glide habitats in the reach are related to the straight sections of the channel that have homogenous habitat conditions. Several of the pools were also located through the reach. Large wood anchored in the river bed provided flow divergence and habitat diversity (Figure 4-11).

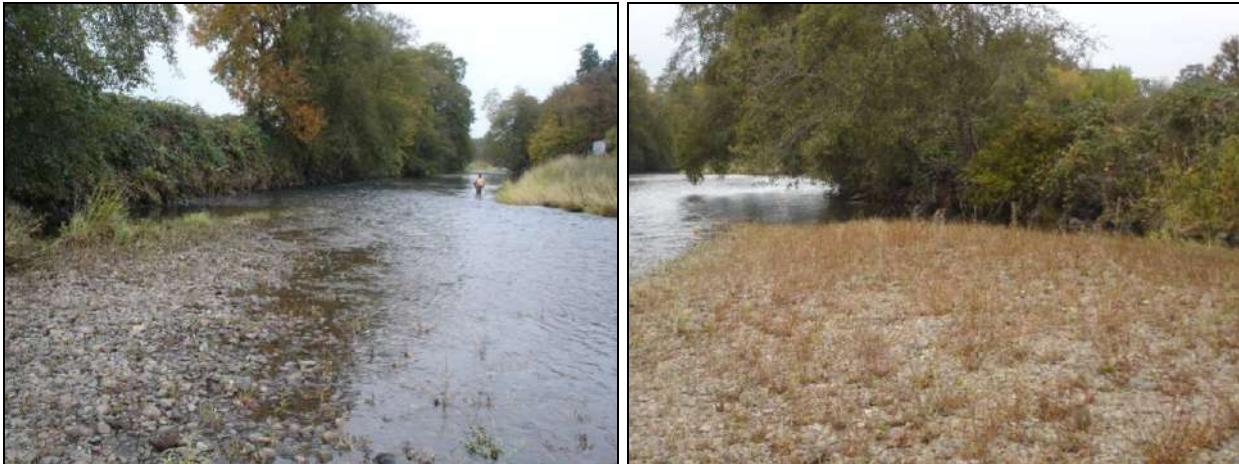
Figure 4-12. Examples of bank stabilization in Reach 4. The left bank is stabilized in upper Reach 4 (left). Blackberry bushes and deciduous trees have colonized the riprap. The right photograph shows a backwater habitat that has formed between a gravel bar and the adjacent riprap bank at station 309+00.

The riprap sites were generally short and were likely installed during the 1962 effort. Riprap is largely grown over with shrubs, blackberry, and overstory deciduous trees. Figure 4-12 depicts bank stabilization projects in Reach 4.

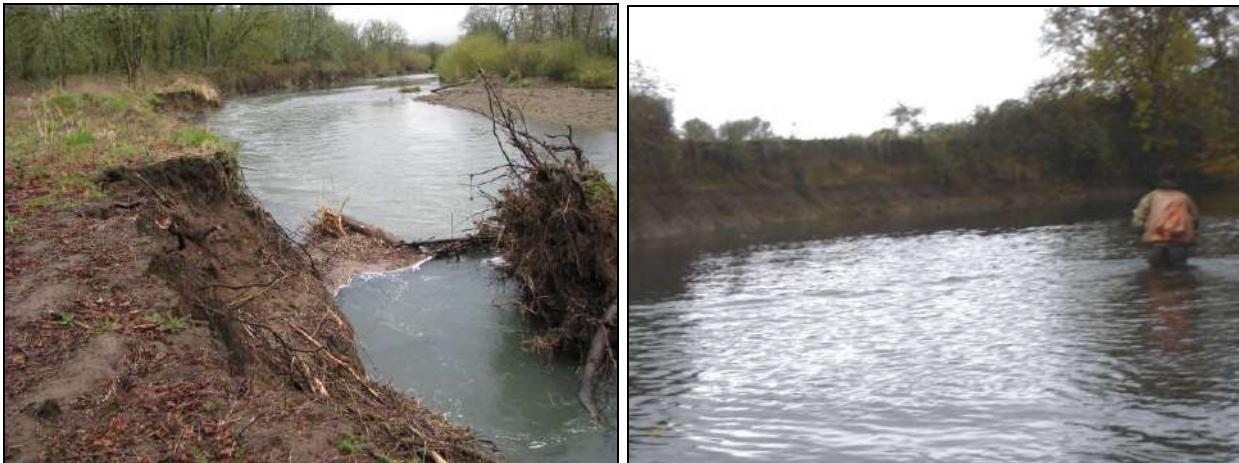
Figure 4-13. Example streambank failures in Reach 4 include the Smith property (left – photo courtesy of T. Putney) and the bank at Sta. 354+00 (right).

Bedrock and coarse bed material limit bank erosion in upstream half of Reach 4. However, streambank failures are prevalent in the downstream half of the Reach 4, primarily affecting the southern streambank. The bank erosion occurring at the Smith property exemplifies the mass wasting taking place in some portions of Reach 4 (Figure 4-13). Erosion at Sta. 354+00 and 366+00 is influenced by tight, low radius meanders. These two meanders may be influenced by the riprap bank that separates them. Sediment sources are delivery fine silts, clay, and sand material to the Calapooia River. These banks will continue to erode until an angle of repose is achieved. Based on the current vertical nature of these sites, they will continue to erode for the foreseeable future. Summary bank erosion metrics are included in table

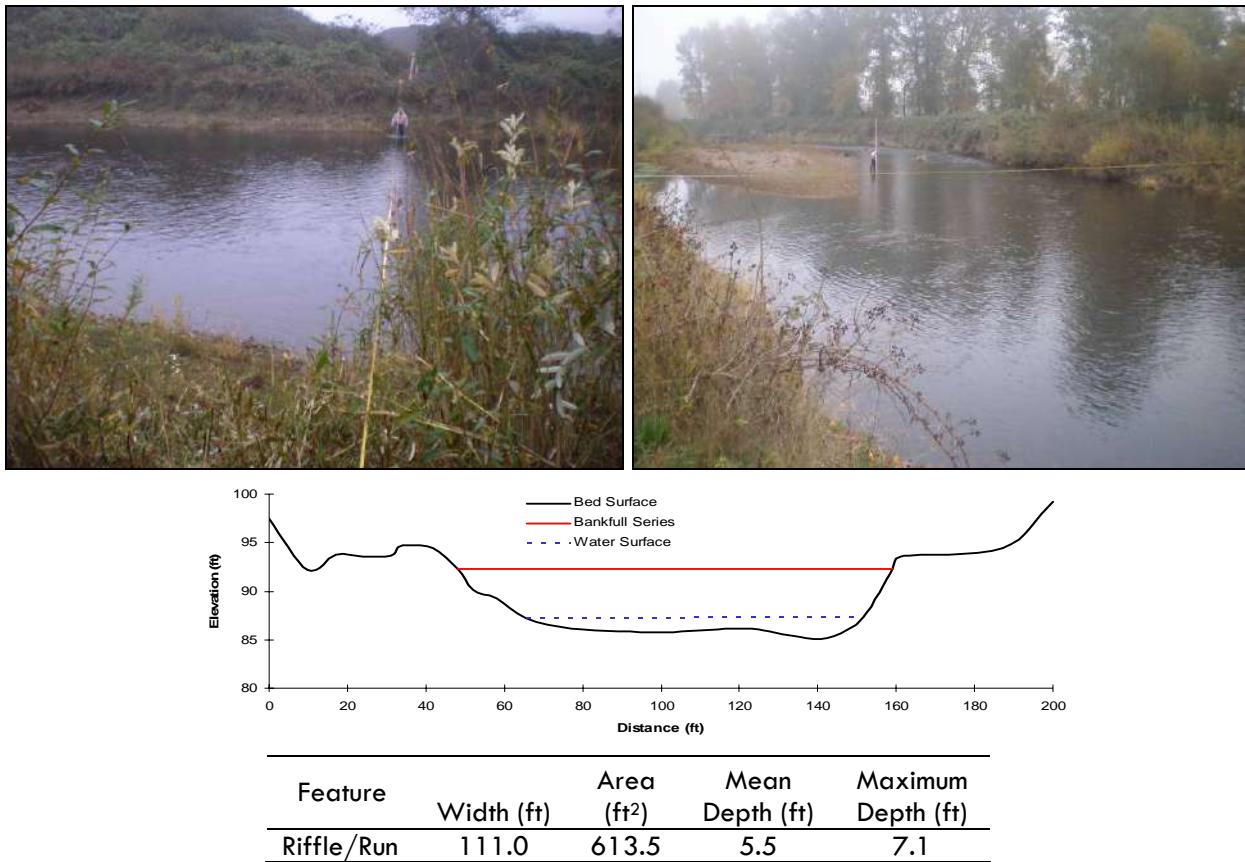
Figure 4-14. The Reach 4 cross-section at Sta. 394+00. The upper left photo shows a view across the river to the left bank. The right photo captures the river corridor through the cross-section location looking upstream.

A hydraulic channel cross-section was established in Reach 4 adjacent to the Knife River gravel mining operation upstream from the Sodom Dam channel bifurcation. The cross-section was located immediately upstream of a backwater habitat unit. The channel survey was completed on October 30, 2007. The survey included a cross-section, channel profile, discharge measurement, and pebble count. Summary information from the survey is included in Figure 4-14. The photos show typical river corridor conditions in the downstream portion of Reach 4. The right bank separating the gravel extraction area is stabilized with riprap. The left streambank is not stabilized. A narrow riparian strip separates upland agricultural fields from the Calapooia River on the south bank.

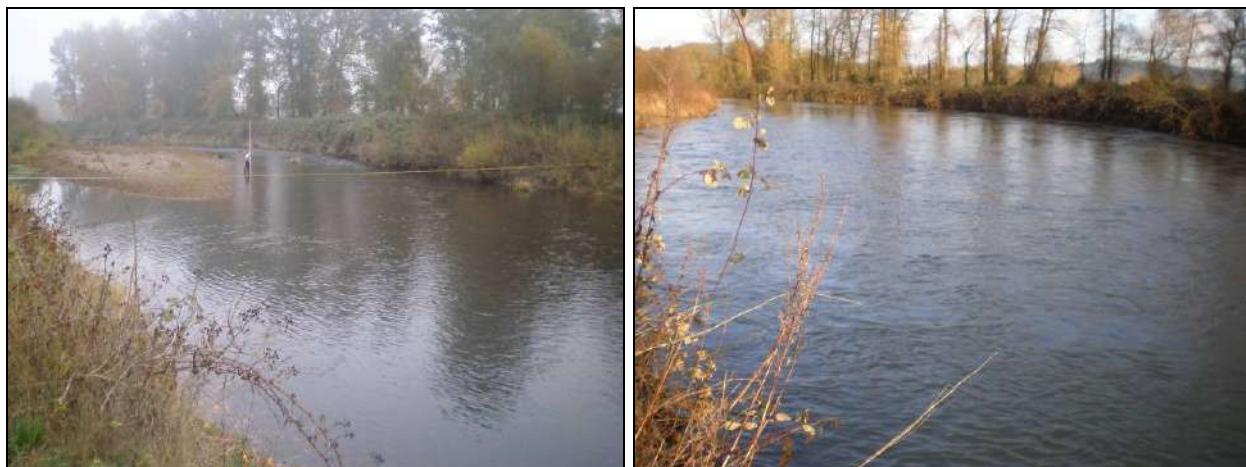
Figure 4-15. A comparison of the Calapooia River at 40 cfs (left) and approximately 1,800 cfs (right) at the Reach 4 hydraulic cross-section. The backwater habitat in the left side of the baseflow photo was completely inundated during the 1,800 cfs event. The 1,800 cfs event was approximately one-third of the estimated 2-year discharge.

Figure 4-15 shows the Reach 4 hydraulic cross-section location at the time of the survey and during elevated discharge during January 2008. A discharge measurement was not completed during the January site visit due to hazardous conditions.

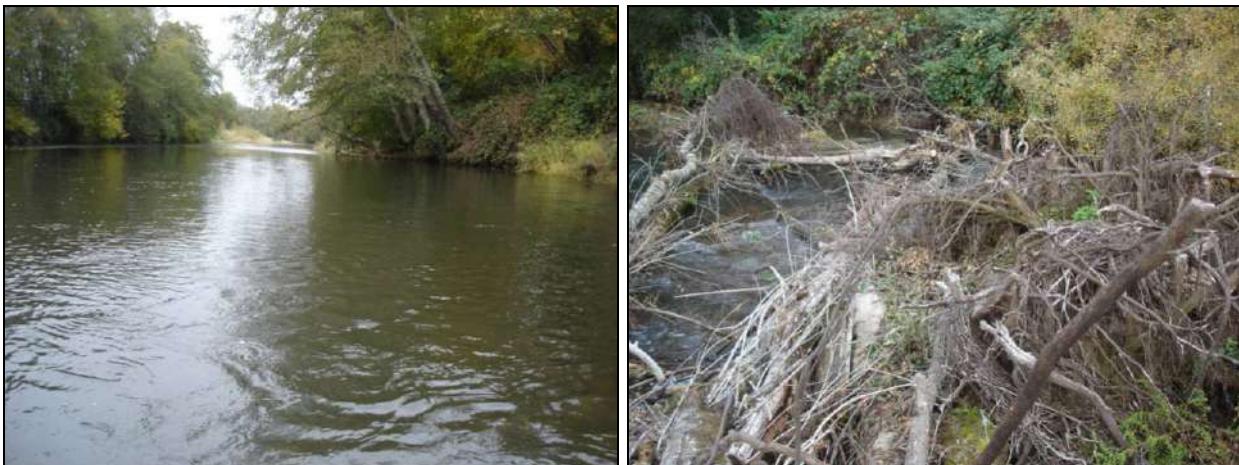
Figure 4-16. The upstream half of Reach 4 is characterized by a plane bed channel with homogenous conditions (left). Large wood accumulations in the depositional areas of Reach 4 offer cover and lower water velocities that are beneficial for juvenile fish rearing.

Fish habitat through Reach 4 varies between homogenous glide habitats in the straight sections of the channel, to diverse backwater habitats located in the depositional areas of the reach. Floodplain channels are limited in the reach due to the narrow river corridor. Large wood is prevalent in the depositional sections, creating both cover and varied hydraulics. Wood is generally lacking in the straight sections, offering an opportunity to enhance channel margin juvenile rearing habitat. Example Reach 4 habitats are shown in Figure 4-16.

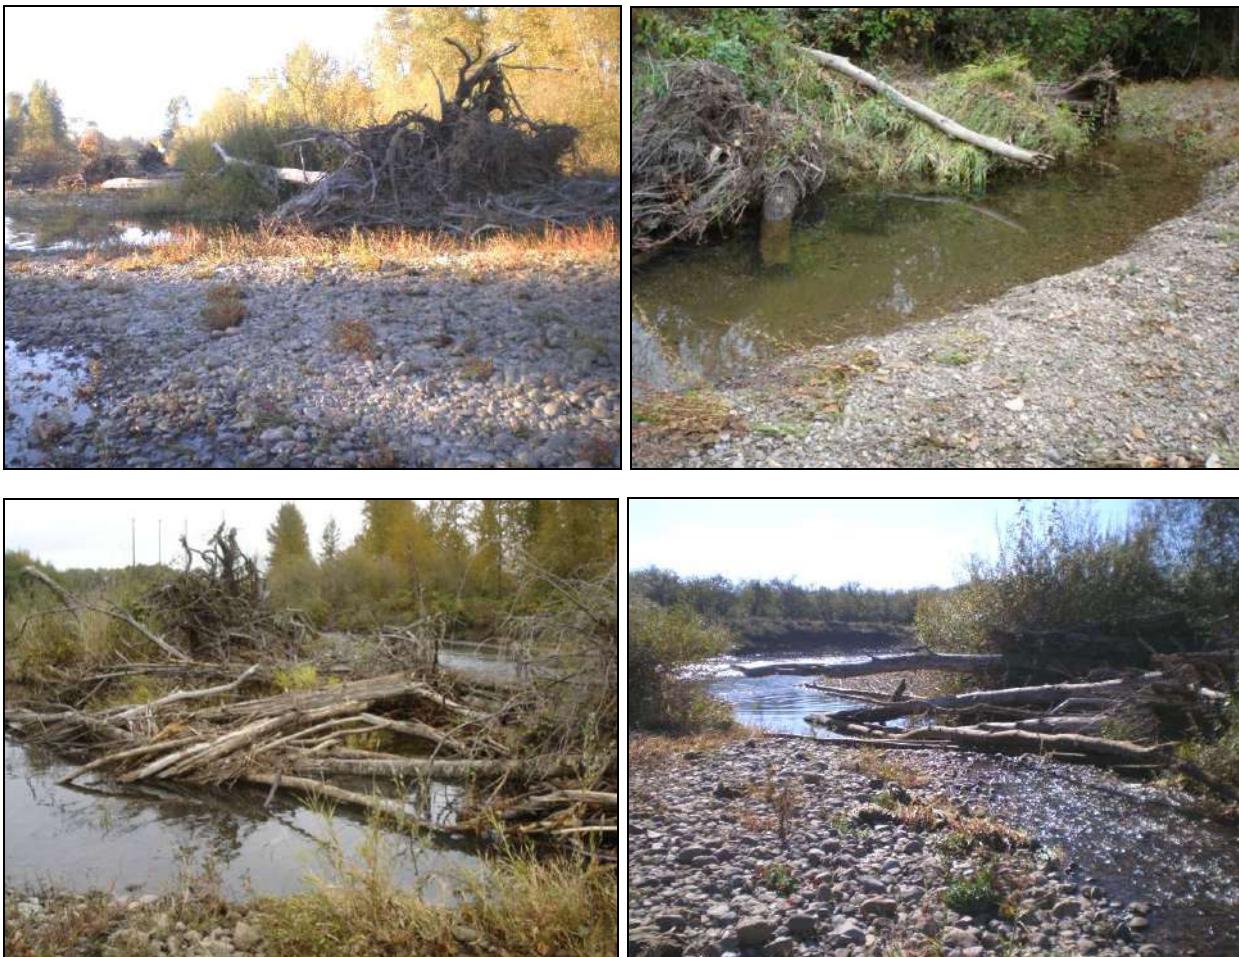
Figure 5-1. Examples of large wood in the Middle Calapooia River. Large wood influences sediment deposition patterns, focuses stream flow creating scour, provides cover for fish and wildlife, and captures additional debris.

How wood functions also depends on its location within the river corridor. Wood in the mainstem river is typically more mobile than floodplain wood as mainstem debris experiences higher velocities and shear stress. Floodplain wood experiences lower velocities and is less prone to mobilization. Vegetation can trap large wood and create rafts of debris. Vegetation may also colonize the fine sediments that typically deposit in the leeward direction of wood, and over time, vegetation anchors the wood. Figure 5-1 includes several examples of large wood in the Calapooia River. Photos illustrate the role of wood in forming channel morphology, providing fish habitat, and influencing channel hydraulics.

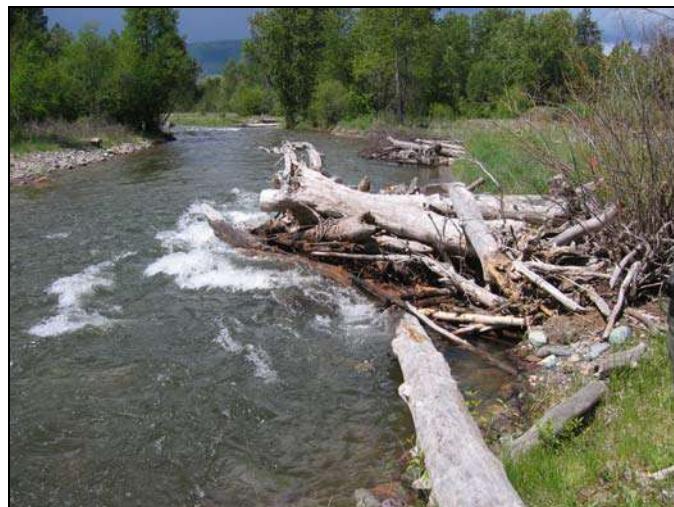
Figure 5-2. An ELJ constructed on the Jocko River in western Montana following two run-off events.

Engineered log jams (ELJs) are installed for bank stabilization, flow deflection, and mainstem river habitat. ELJs will be completed on the mainstem river and will provide complex cover for juvenile and adult fish. ELJs will be constructed with approximately 10 to 15 trees including rootwads, whole trees, and tree tops (Figure 5-2). To provide structure ballast, approximately 10 yd³ of large rock will be placed within each structure. The ELJs are also backfilled with native alluvium to reduce the potential for intra-structure piping. Rootwad sizes will average 3 ft to 4 ft in fan diameters and have minimum stem lengths of 30 ft. ELJs span from the predicted scour depth to above the bankfull channel elevation to provide a range of fish habitat and structure stability.

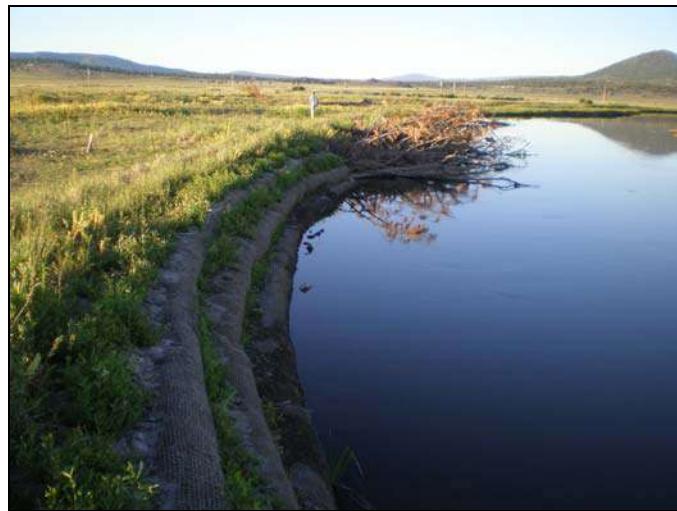
Figure 5-3. A vegetated soil lift following spring runoff and at the start of the growing season on the Sprague River.

Vegetated soil lifts is a bioengineering technique that combines layers of dormant willow cuttings and/or containerized willows with fabric-wrapped soil to revegetate and stabilize stream banks and slopes (Figure 5-3). Vegetated soil lifts are proposed for stabilizing bank erosion sites where a new bank face will be constructed. To construct a vegetated soil lift, a coarse cobble toe is first established. The first soil lift incorporates a high density coir log backed with soil and wrapped within two layers of biodegradable coconut (coir) fiber fabric. Dormant willow cuttings or containerized plants and a native seed mix are placed on each lift. The cuttings or plants are placed horizontally to extend into the stream channel. Cuttings should be placed so that only $\frac{1}{4}$ of the cutting is exposed. A two to three-inch layer of top soil is placed between each lift to reduce air pockets and provide rooting medium for the willow cuttings. The coir fabric holds the soil in place while vegetation becomes established in the relatively high stress land/water interface. Vegetated soil lifts will provide near-term bank protection until planted vegetation becomes established.

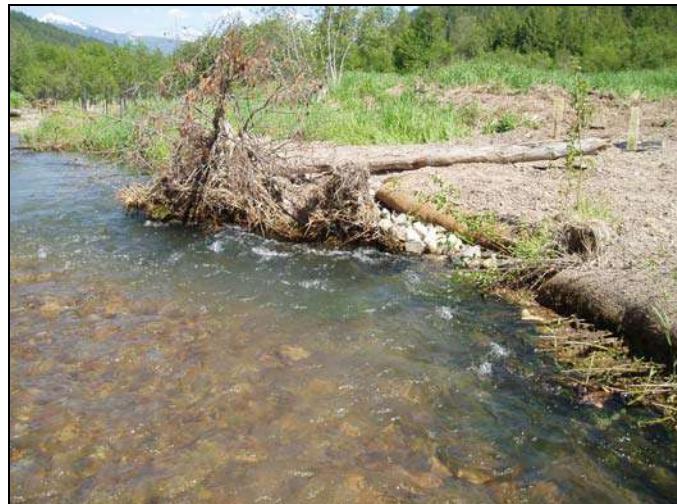
Figure 5-4. A large wood habitat composite with adjacent soil lift on Pilgrim Creek in western Montana.

Large wood will be used to enhance floodplain channels and backwater habitats. Large wood will be installed both singularly and in aggregate. These structures will be smaller than ELJs and require less material (Figure 5-4). In general, each structure will include at two rootwads and several logs for ballast. Large wood structures may either be anchored in the ground, ballasted with large rock, pinned together, or longer tree pieces will be placed in the riparian zone angled towards the channel.
