Cox Creek Confluence Restoration – Plant Establishment  
Grant #212-3999-9894 *Progress Report*  
Calapooia Watershed Council  
June 5, 2015

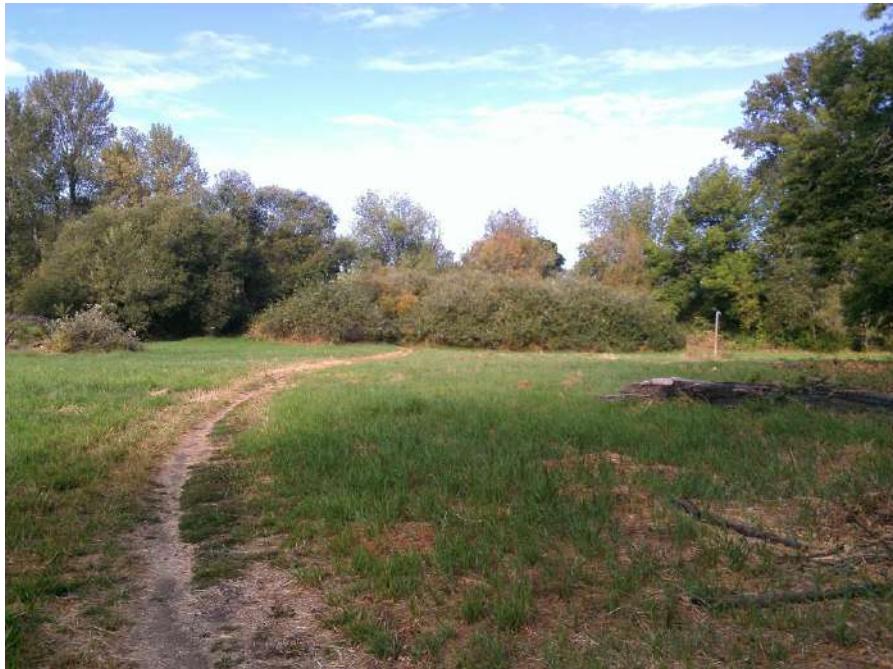
Figure 3. Cox Creek Confluence vegetation photo point - BEFORE. Post flail mow, pre reed canarygrass spray, summer 2012.

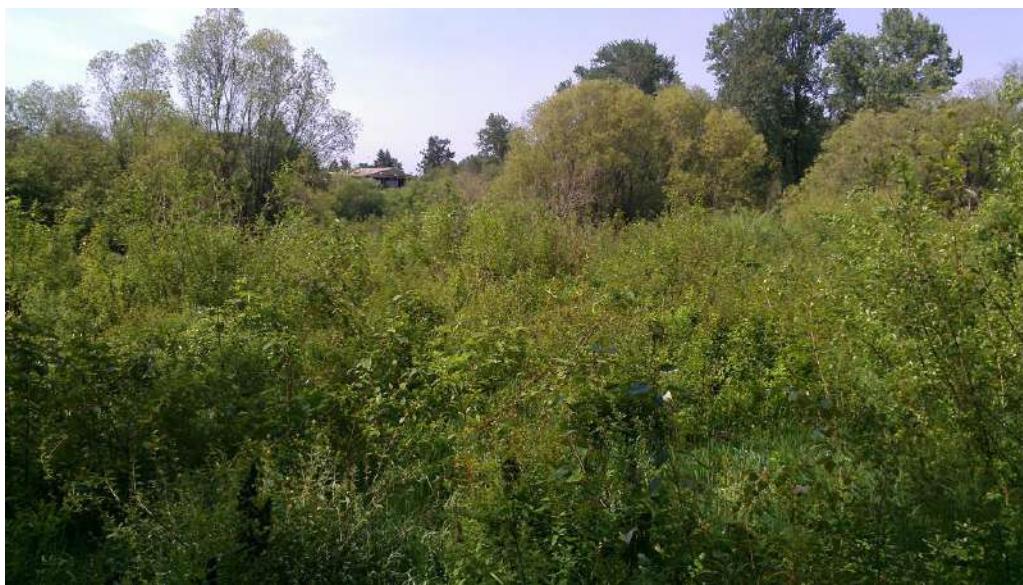
Figure 4. Cox Creek Confluence vegetation photo point - AFTER. Post site prep, planting, and 2 seasons of plant establishment, summer 2014.

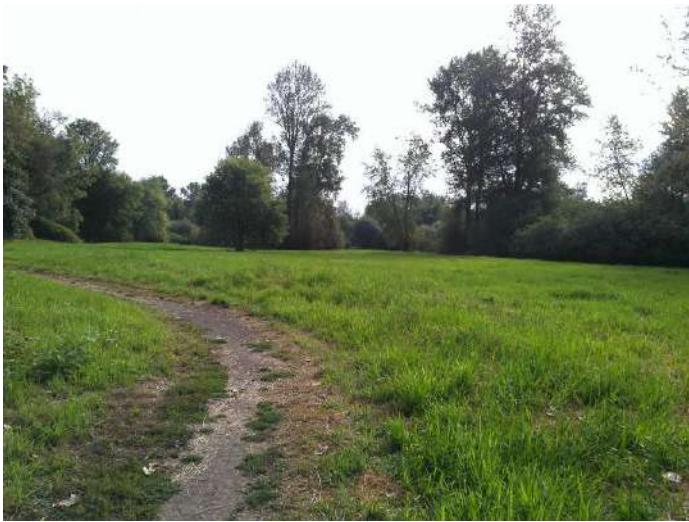
Figure 5. Cox Creek Photo Point - BEFORE. Post flail mow, pre reed canarygrass spray, summer 2012.

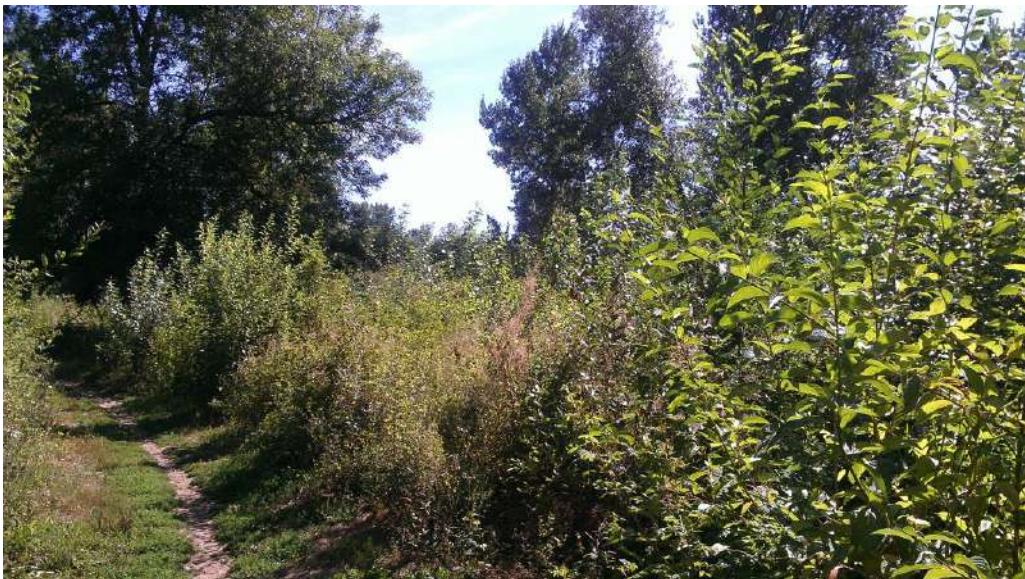
Figure 7. Cox Creek Photo Point - AFTER. Post planting, after 2 seasons of plant establishment, summer 2014.

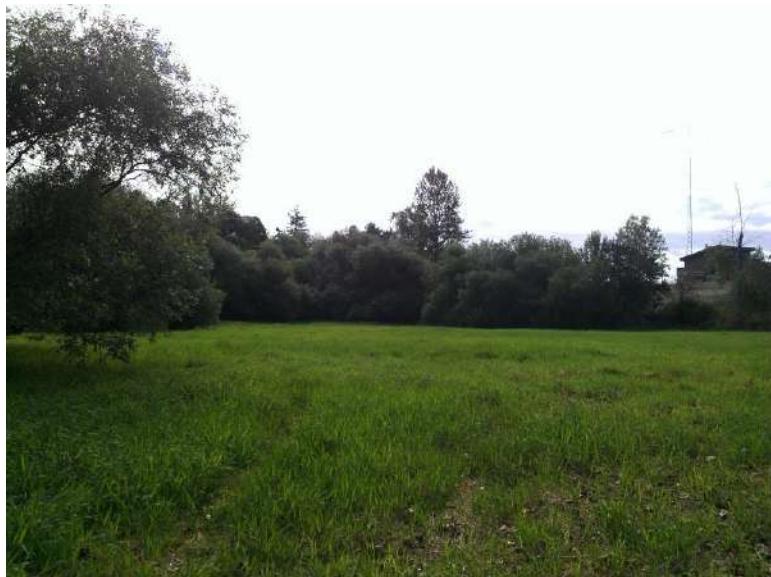
**Figure 8. Cox Creek Photo Point - BEFORE.** Post reed canarygrass flail mow, pre spray and pre planting, summer 2012.

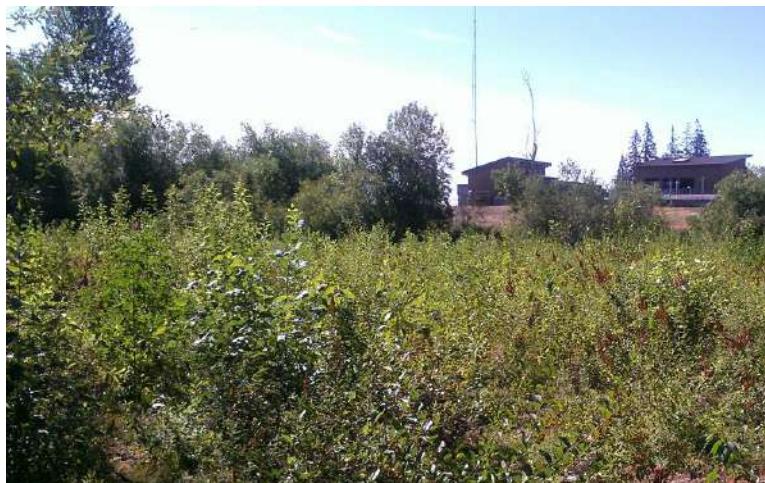
**Figure 10. Cox Creek Photo Point - AFTER.** Post planting, 2nd year of plant establishment, summer 2014.
