# **Brownsville Dam Removal**

## **Pre-Implementation Monitoring Summary**

**September 30, 2007**

**Prepared:  
for Calapooia Watershed Council, OWEB  
by Desiree Tullos, Oregon State University**

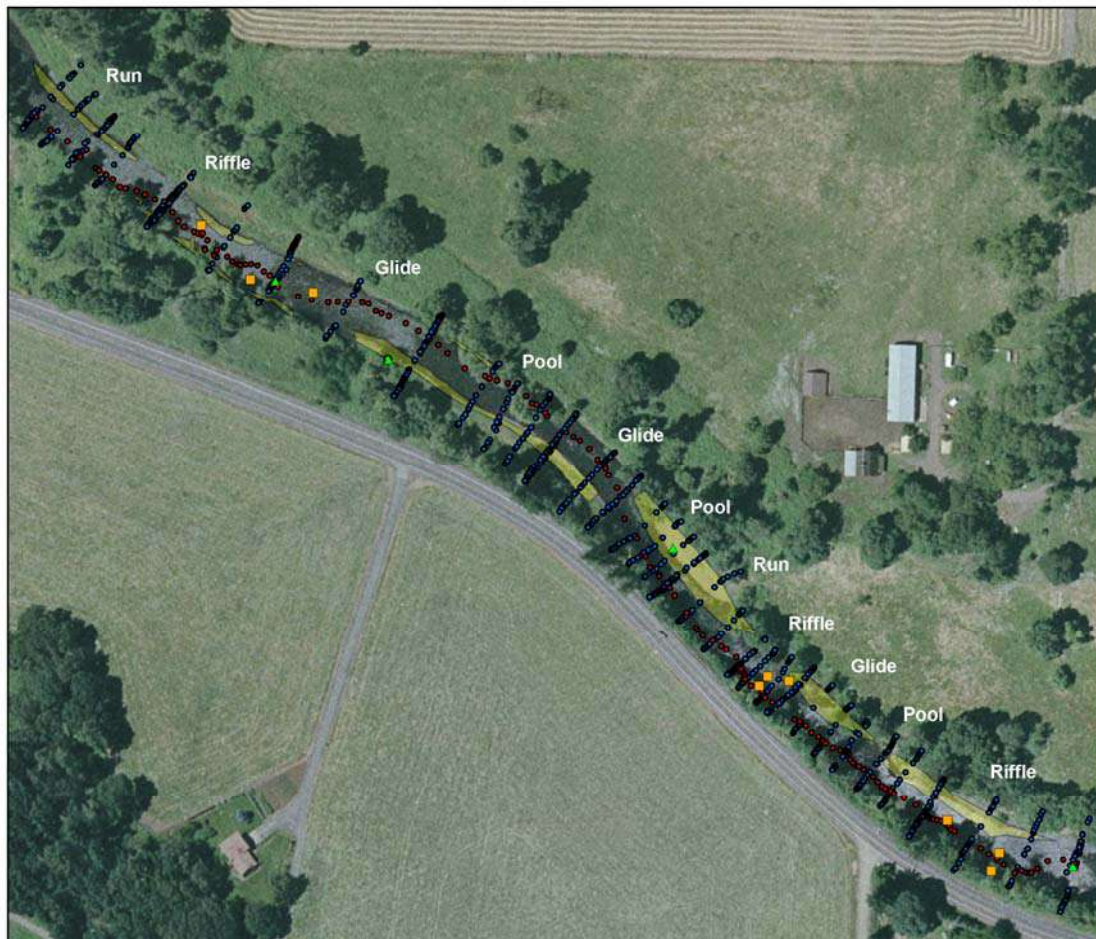
**Figure 2 – Upstream study reach**

- Upstream - control reach above the influence of the reservoir for 20 active channel widths (Figure 2)
- Reservoir – beginning at the old dam site and extending upstream to edge of impoundment when boards were in place (Figure 3)
- Downstream 1 (DS1) – immediately below the same for 20 active channel widths (Figure 4)
- Downstream 2 (DS2) – immediately below DS1 for 20 active channel widths (Figure 5)

**Upstream Study Reach of the Calapooia River  
Near Brownsville, OR**

Channel units (e.g. riffle, run, pool, glide) were mapped for each reach (Figs. 2-5). Reaches were further divided into thirds for four cross-sectional surveys (top, 1/3, 2/3, bottom). Every third cross-section was repeated to estimate measurement error of the surveys. Longitudinal profiles mapped the thalweg across the entire distance of each reach. Point and lateral bars were mapped to evaluate size and location of gravel storage in the channel before and following removal. Survey data will be utilized to calculate metrics describing channel pattern, profile, and dimension.

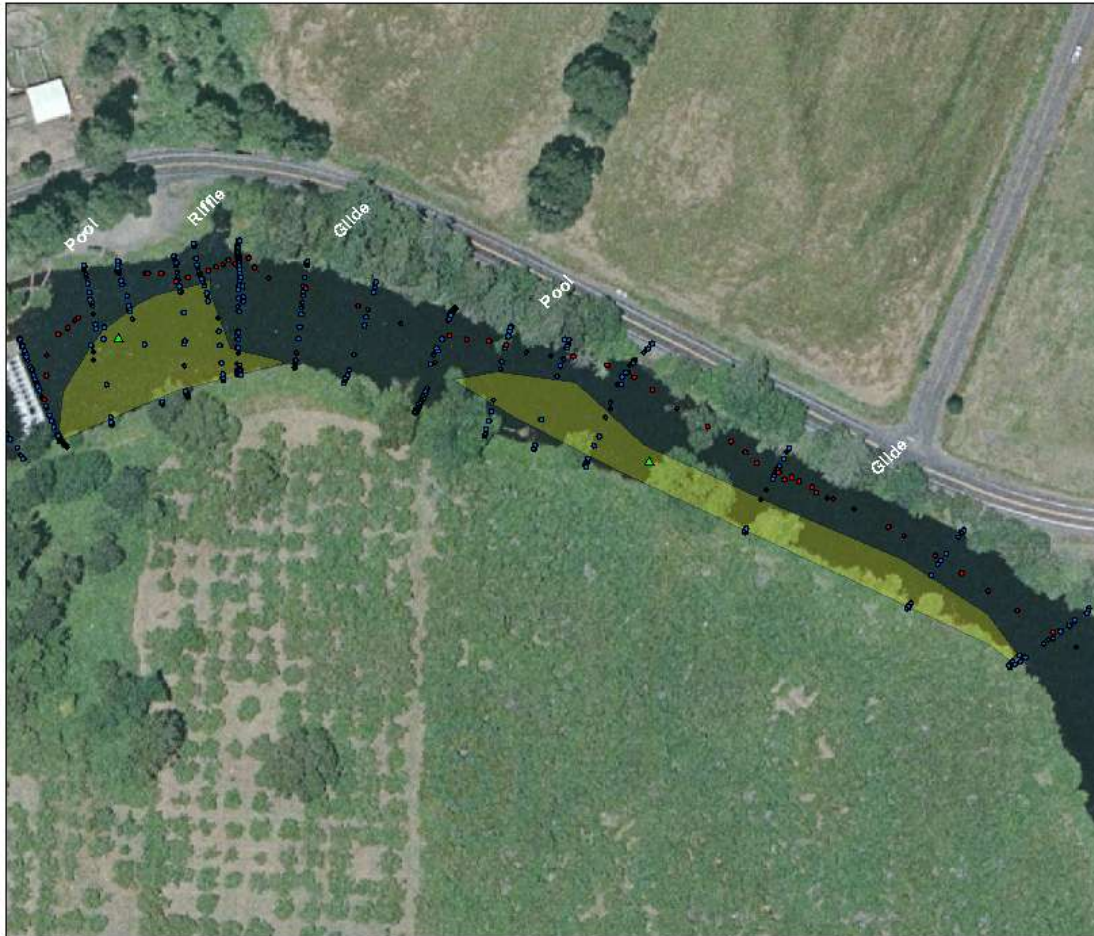
**Figure 3 – Reservoir study reach**

**Reservoir Study Reach of the Calapooia River  
Near Brownsville, OR**

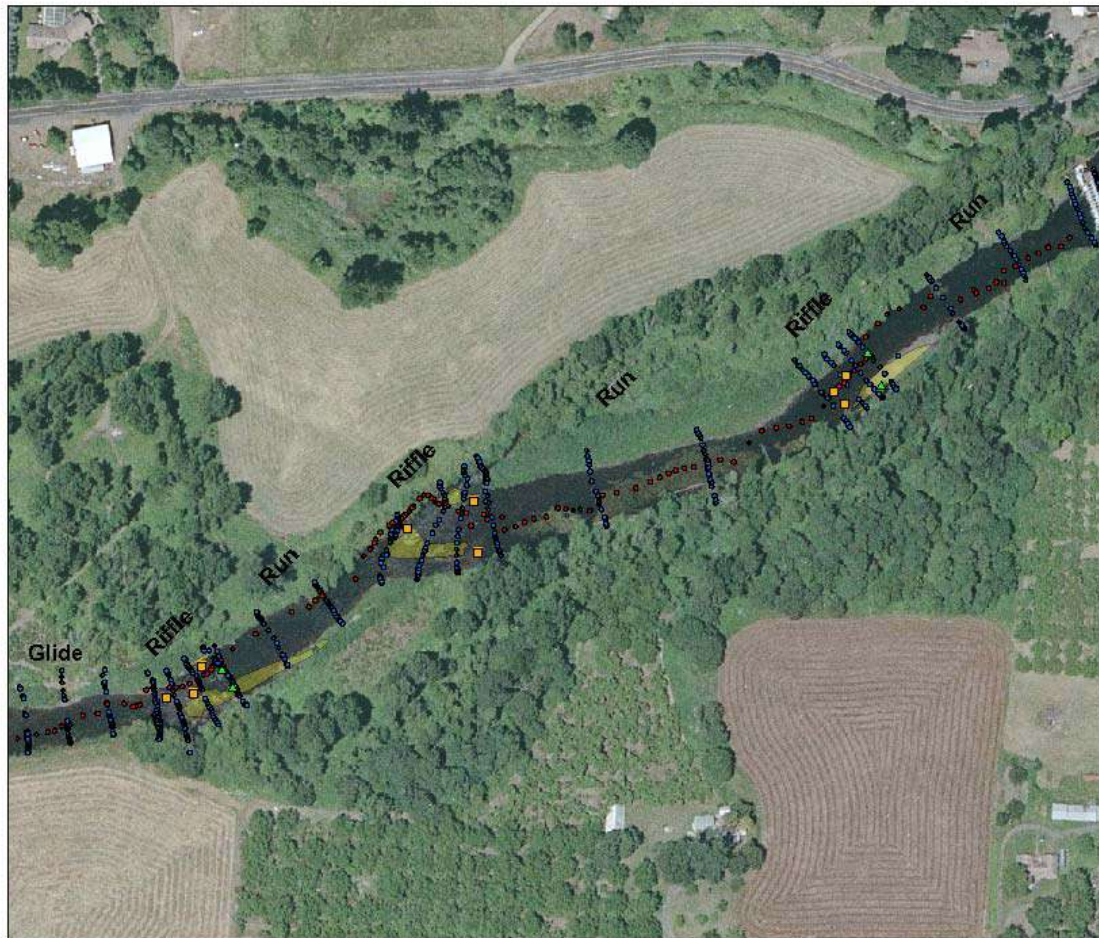
**Figure 4 –Downstream 1 study reach**

Near Downstream Study Reach of the Calapooia River  
Near Brownsville, OR

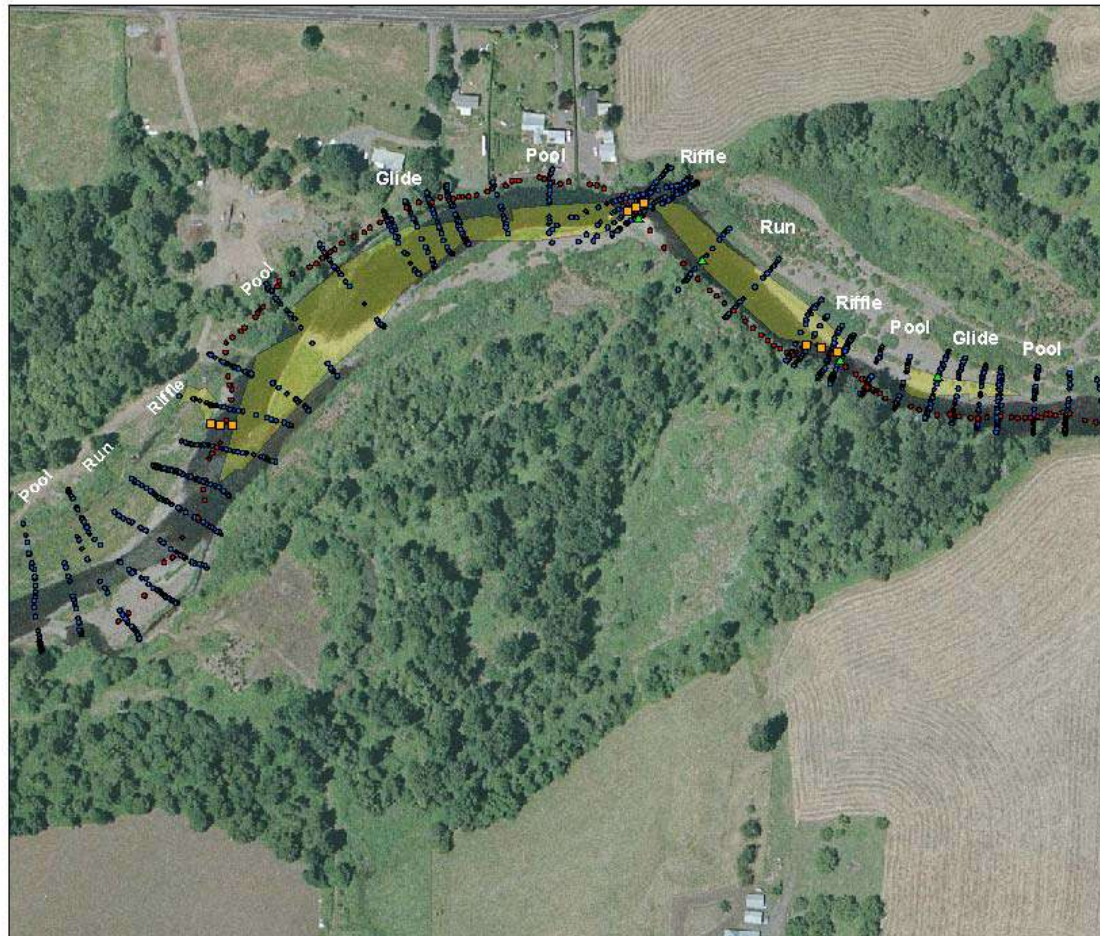
**Figure 5 – Downstream 2 study reach**

**Far Downstream Study Reach of the Calapooia River  
Near Brownsville, OR**
